# Home Report

survey report on:

| Property address | 80 Alloa Road<br>Clackmannan<br>FK10 4EY |
| Date of inspection | 13/03/2026 |

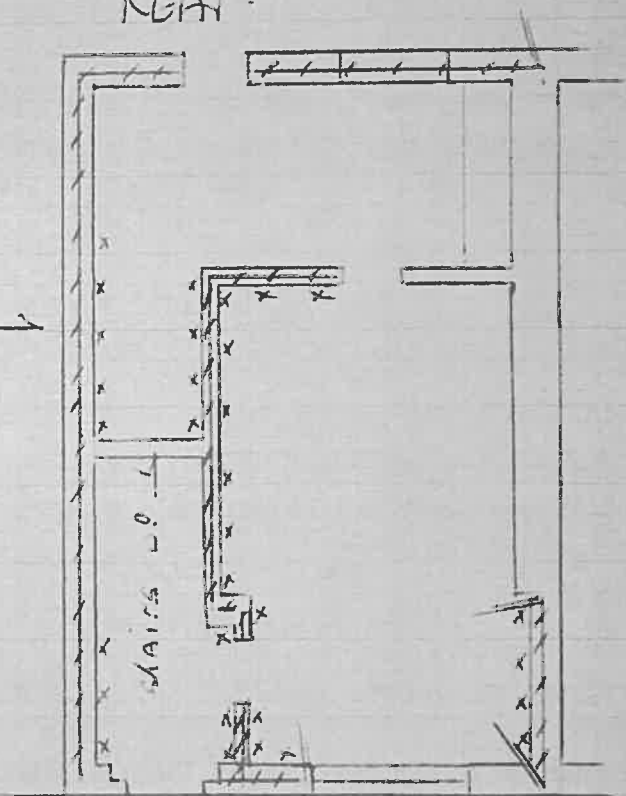
Approx Part Sketch Plan  
OF GROUND FLOOR LEVEL.  
REAR.

EXTERNAL D.P.C. →

++ CHEMICAL DAMP PROOF COURSE TO BE INSERTED.

✓ VERTICAL BARRIERS TO BE INSERTED.
