YOUR ONESURVEY
HOME REPORT

33 Langside Drive
Blackridge
Bathgate
EH48 3RP

SINGLE SURVEY

ENERGY REPORT

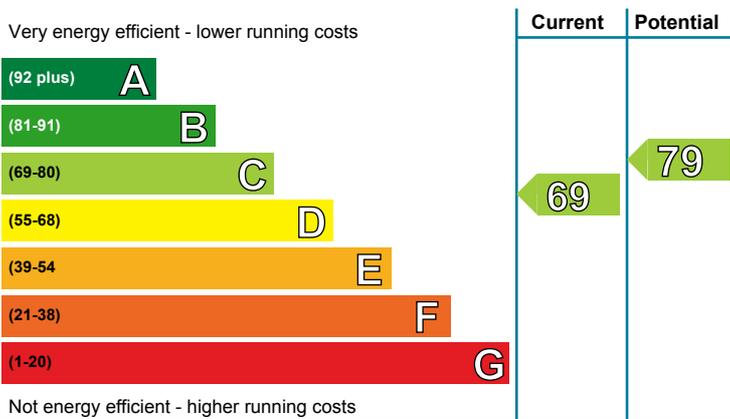
Energy Efficiency Rating

This graph shows the current efficiency of your home, taking into account both energy efficiency and fuel costs. The higher this rating, the lower your fuel bills are likely to be.

Your current rating is **band C (69)**. The average rating for EPCs in Scotland is **band D (61)**.

The potential rating shows the effect of undertaking all of the improvement measures listed within your recommendations report.

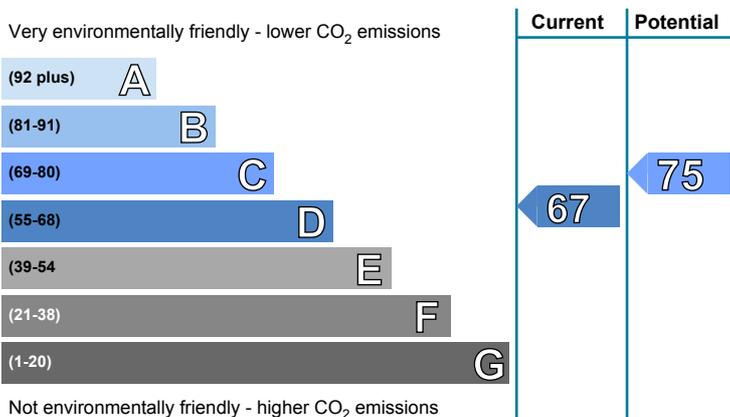
Environmental Impact (CO₂) Rating

This graph shows the effect of your home on the environment in terms of carbon dioxide (CO₂) emissions. The higher the rating, the less impact it has on the environment.
